Saddle Mountain Service Corporation Board Meeting Minutes

Preliminary Engineering Report

SADDLE MOUNTAIN SERVICE CORPORATION

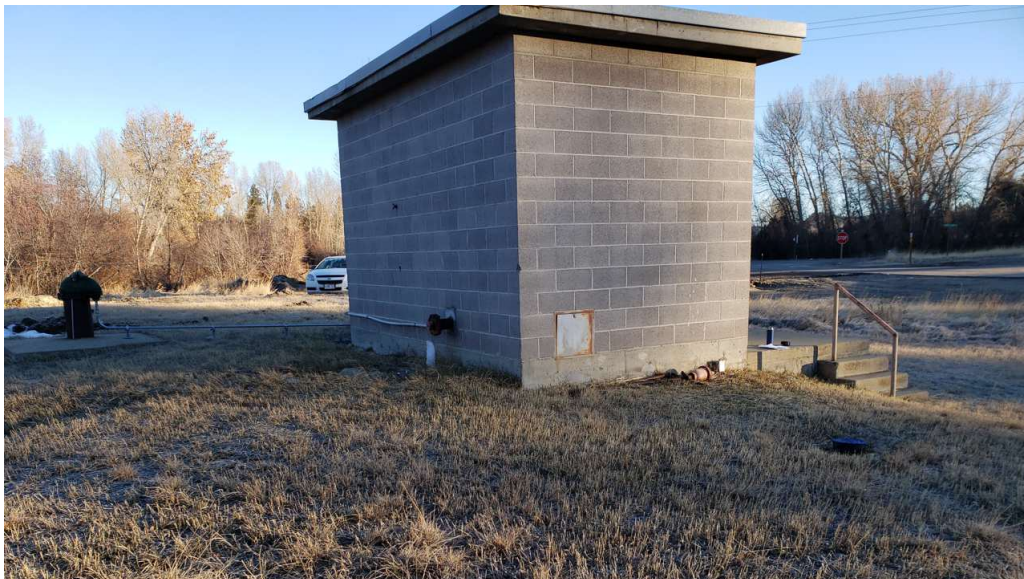
Figure 2-2 - Lower Well House (Well 3 shown on the left)

Images of the lower well house are shown in Figures 2-2 through Figure 2-4.

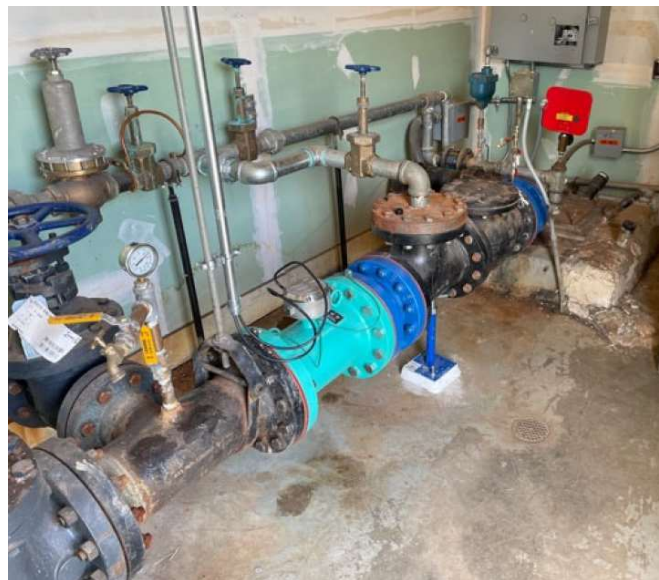
Figure 2-4 - Lower Well House (Inside showing Well 1, and meter)

Figure 2-4 shows the internal piping and also the new flow meter retrofitted with the lower well house piping in 2021. The panel showing instantaneous and totalized flows is mounted on the wall near the door. Two-inch galvanized piping is currently routed from the Well 1 pump discharge. Well 1 was originally designed for a VT pump with an intake set 40 feet below the surface and later converted to a submersible pump. The original discharge piping (excluding new piping associated with the flow meter installation) associated with Well 1 is observed to be corroded. The system could be revised to be simplified with fewer fittings. Additionally, the

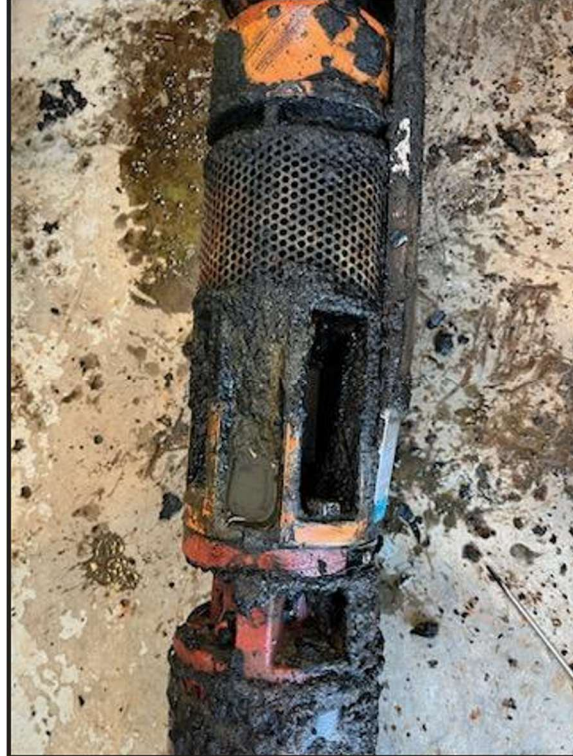
Figure 2-5 - Existing Well 1 Pump (Removed)

The Well 1 drop pipe was deteriorated, limiting production from the well and entraining air into the well water, which may have decreased pump performance over time. The pump itself was corroded and worn. The 2-inch galvanized drop pipe was replaced for the pumping test in Well 1, but the pump/motor appeared to have reached the end of its serviceable life.

No records were available with respect to the historical production of the two wells. However, inspection and testing of the wells indicates the submersible pump in Well 1 was set within the perforated interval and operated in a manner that likely drew the PWL into the screened interval, producing cascading condition and air-entrainment, decreasing the pumping rate and cavitating the pump, damaging the pump over time.

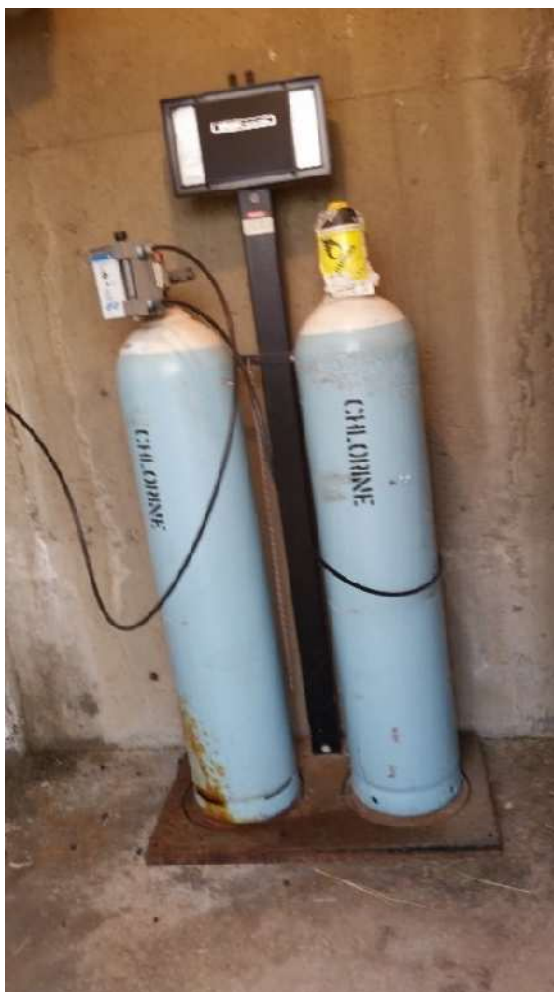
Figure 2-6 - Gas Chlorine Tanks

SMSC treats drinking water by means of full-time chlorination using gaseous chlorine injection. Water from Wells 1, 3, and 5 is disinfected at the Mid Station storage facility. In the last two years, no significant DEQ violations have been noted in the system, which appears to be adequate for its disinfection needs. Despite the safety concerns of using a gaseous system, SMSC does not want to consider the conversion to liquid sodium hypochlorite injection due to potential increased chemical costs and operator familiarity reasons. Figure 2-5 shows the existing gas chlorine tanks.

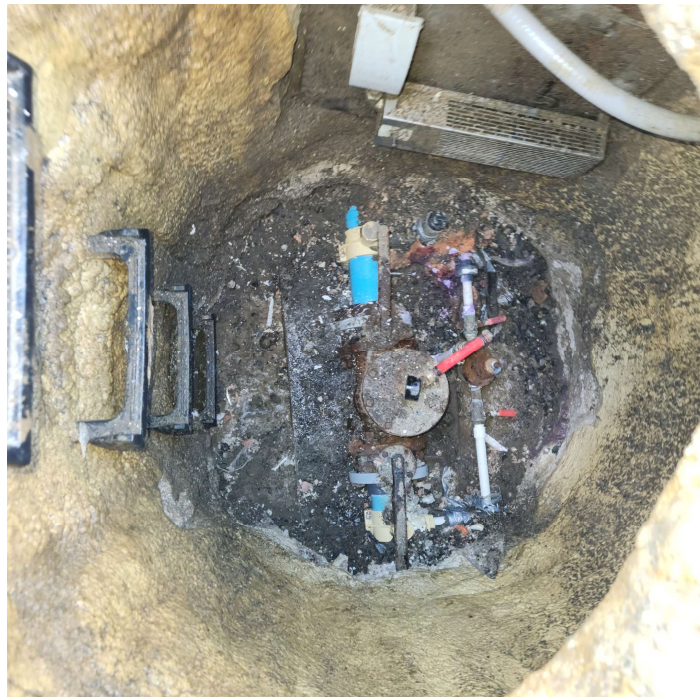
Figure 2-10 - Existing PRV Station

The estimated flow range of the PRV station is likely from about 5 gpm to 200-300 gpm, for average day flow conditions to peak flow demands during irrigation periods. The PRV assembly is set in a manhole and accessed from the surface. Despite being insulated on the walls and top access, the valves have been reported to freeze during extended periods of extremely cold temperatures (below zero degrees F), so a heater has been wired into the space. A photo of the existing PRV station is shown in Figure 2-10, below.

The PRV station is sized for 4-inches high flow and a 1-inch low flow. At the time of the photo, the low flow side appears to be valved off. The image indicates the PRV valves are in a corroded state, and the bolts are not accessible around the entire assembly. It is not likely that the valves have been replaced or rebuilt since installation. The current operations personnel cannot recall if/when the PRV station was rebuilt.

Given the age and condition of the PRV station, it is recommended that SMSC consider replacing the station to protect the downstream users. Pipestone Equipment was contacted to
